Draft Translation 753

THERMOGRAPHY CONTROL OF HEAT INSULATION AND TIGHTNESS OF BUILDINGS

. Axen and B. Pettersson

UNITED STATES ARMY
CORPS OF ENGINEERS
COLD REGIONS RESEARCH AND ENGINEERING LABORATORY
HANOVER, NEW HAMPSHIRE, U.S.A.

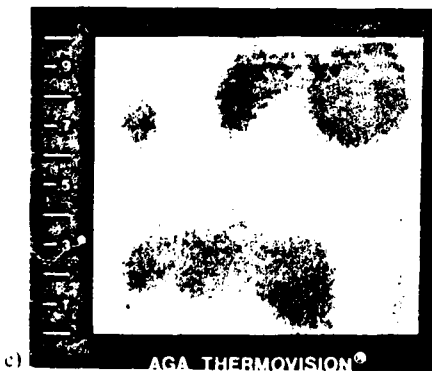
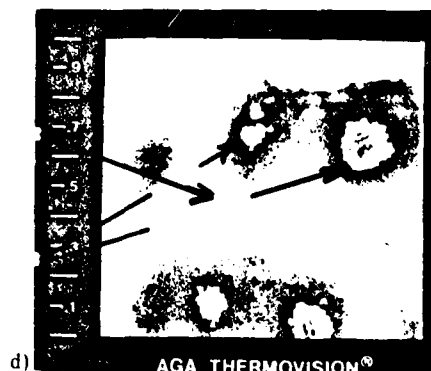
b) Deficiency in insulation and tightness execution, particularly in conjunction with existing clamps[?]

c) Thermogram of portion of outside wall. Cooled portions caused by unsatisfactory insulation execution in combination with convective air movements. The joints (corners) between the insulation panels appear as dark spots.

FIGURE 90: Deficiencies in insulation and tightness due to inward air leakage through construction of joints between the casements.

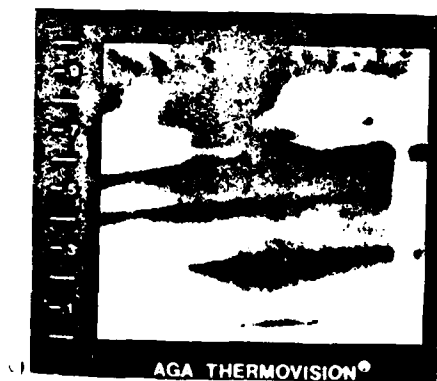
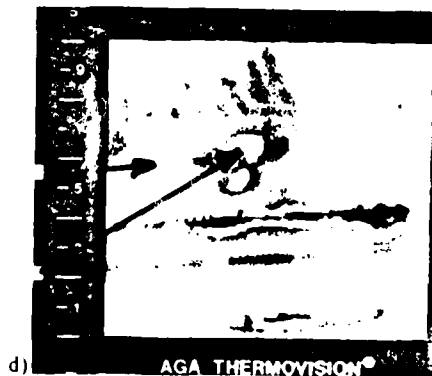
- a) Construction of outside wall with interior and exterior metal siding. Metal casements with joint sealing of rubber strips. Interior metal surface was lacquered.
- b) Air leakage route through the construction.
- c) Thermogram of partially cooled wall portion on the upper part of the wall. The cooling is related to inward air leakage through the construction.
- d) $t_{ref} = + 17^\circ\text{C}$
 $\Delta I = -1.6$ isotherm units
 $\Delta t = 3.0^\circ\text{C}$
 $v = 1.0 - 2.0$ m/s (at horizontal joint between metal casements)

FIGURE 91: Deficiencies in insulation and tightness due to inward air leakage through the construction at joints between the casements.

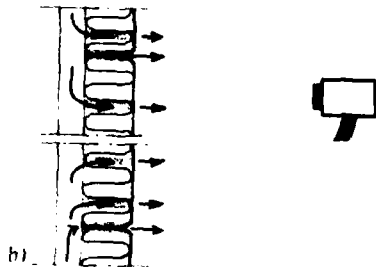
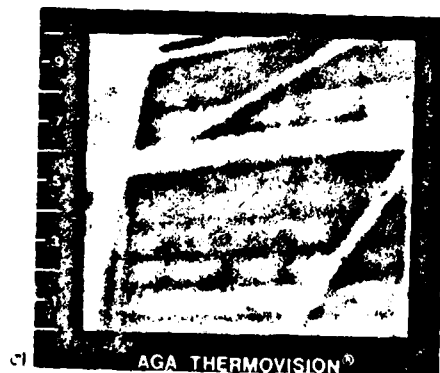
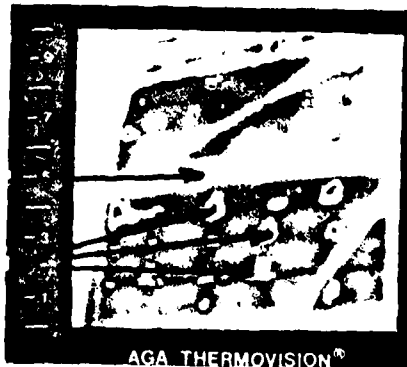
- a) Construction of outside wall with interior and exterior metal facing.
- b) Air leakage through the construction at slots formed by badly fitted mineral wool panels.
- c) Thermogram taken from the inside of partially cooled wall portion. The cooled portions form a certain pattern related to inward air leakage through the construction, particularly at joints between mineral wool panels, resulting in cooled surface portions.

FIGURE 92: Deficiencies in insulation and tightness due to incomplete mineral wool insulation.

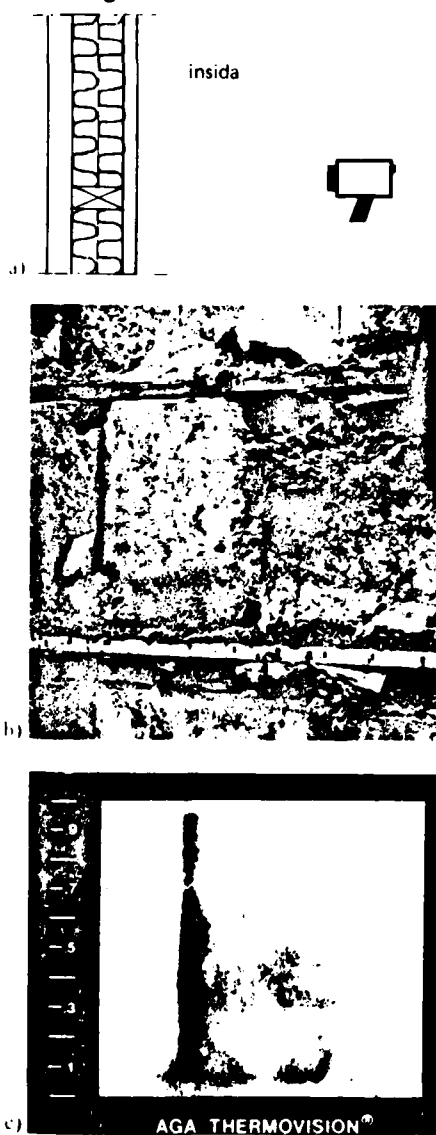
- a) Construction of outside wall with interior and exterior metal siding.
- b) Photography of opened wall portion (from outside).
- c) Thermogram of wall portion at vertical steel profile with uneven temperature distribution. The cooling of certain portions is related to deficient filling with mineral wool. Hollows in spaces between studs are due to rats having removed insulation material.
- d) $t_{ref} = + 11^\circ\text{C}$
 $\Delta I = - 1.1$ isotherm unit
 $\Delta t = 2.5^\circ\text{C}$
 $v = 0.5 - 1$ m/s (at vertical post)

FIGURE 93: Deficiencies in insulation and tightness due to unsatisfactory contact between mineral wool insulation and steel beams.

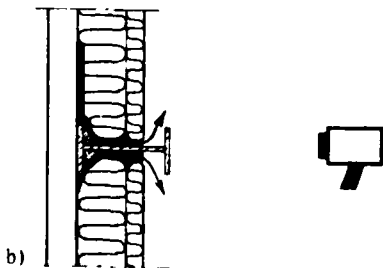
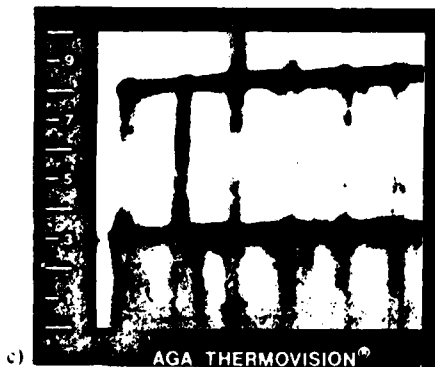
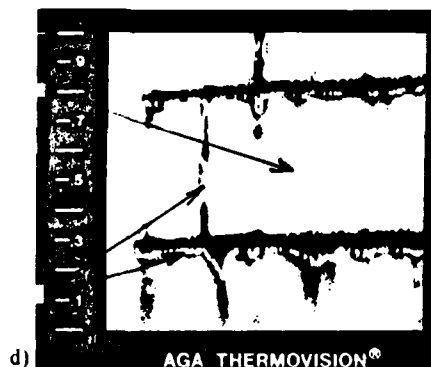
b) Insufficient filling of insulation material
resulting in inward air leakage

c) Thermogram of cooled surface portions of out-
side wall. Cooling caused by inward air leakage
through the construction, primarily at the hori-
zontal steel profiles.

FIGURE 94: Deficiencies in insulation and tightness due to insufficient function of sealing layer.

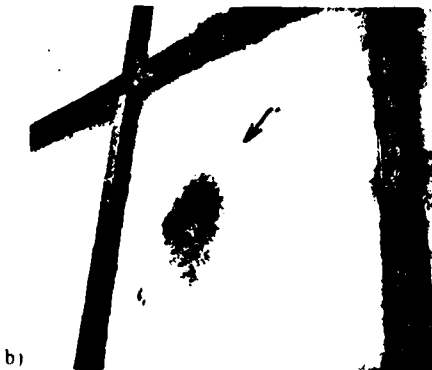
a) Construction of outside wall
b) Outside wall seen from the inside. A darker (soiled) portion appears in the center of the wall area. The soil caused by outward leakage of dirty indoor air through local untight spots in the wall portion.

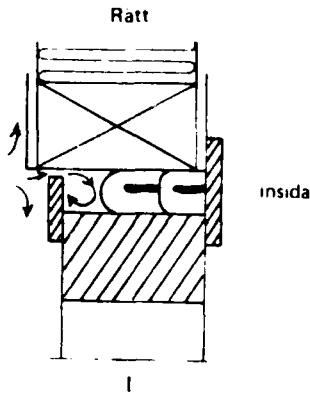
a) Sealing of joint between door frame and wall portion should be performed according to I. Sealing of joint is frequently executed according to II, i.e. with only one caulking strip which is not folded. Outside air leaks inward through the untight joint. The surface portion next to the door frame on the inside of the wall will be cooled. (Top, I: Correct / Inside. II: Erroneous.)

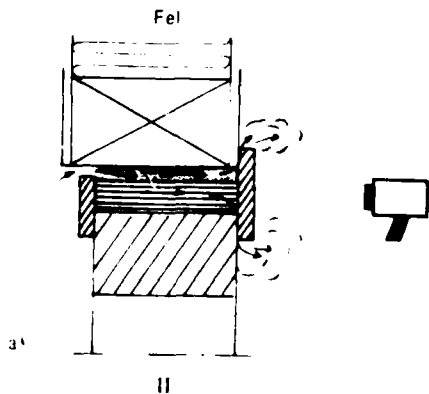
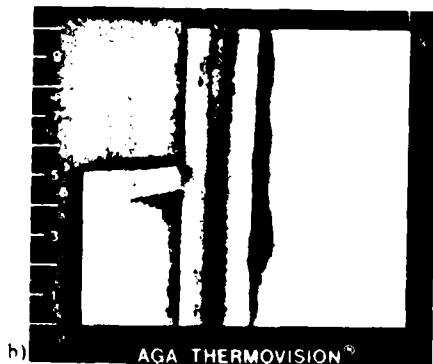
b) Thermogram of surface portion at the joining of the door frame to the wall portion. The temperature difference between normal surface temperature and cooled area is approx. 4°C at this location. The air speed close to the inward leakage is approx. 1 m/s at the wall surface.

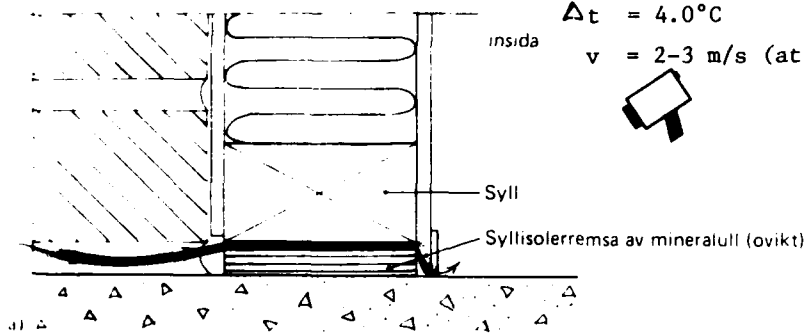
- Alt. a) See FIG. 98. Insulation strips of mineral wool, placed without being folded, under the floor joist, frequently cause relatively strong air leakage at the floor corner, particularly if the surface of the joist tier is uneven. Air movements measured at these leakages varied significantly, e.g. due to the pressure differences throughout the construction. When a control measurement was made twelve months after the final inspection, it was found that the extent of the air leakage had increased. The results from all houses investigated pointed in the same direction.

FIGURE 98: Deficient function at joint at floor joist, with strong inward air leakage.

angle. Cooling caused by inward air leakage through the joint between joist and concrete.

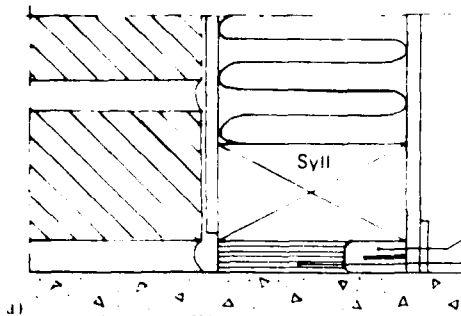
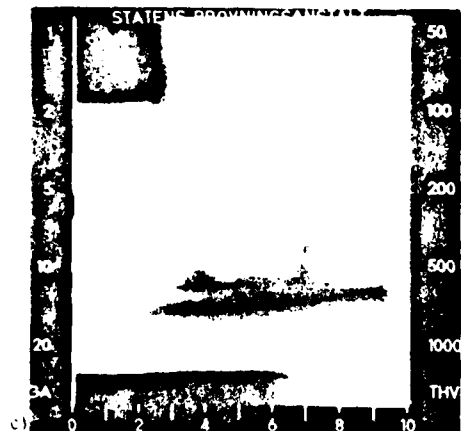
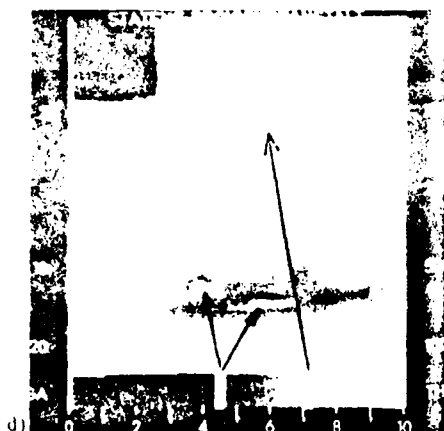
- Alt. b) See FIG. 99. Gullfiber joint fiber system generally gave satisfactory results. Locally, a limited extent of air leakage could be observed. As a rule, there was no change in the results when measurements were made twelve months after the final inspection.

FIGURE 99: Acceptable function of joint at joist with locally inconsiderable inward air leakage at edges of joint sealing material.

Certain limited, cooled surface portions could be observed with this system. Inward air leakage is limited and local.

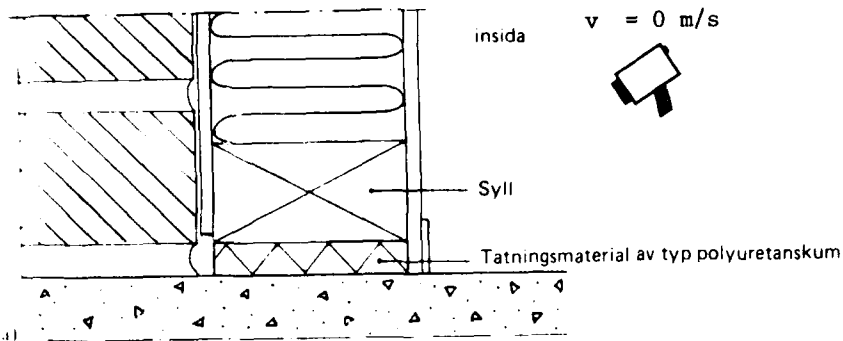
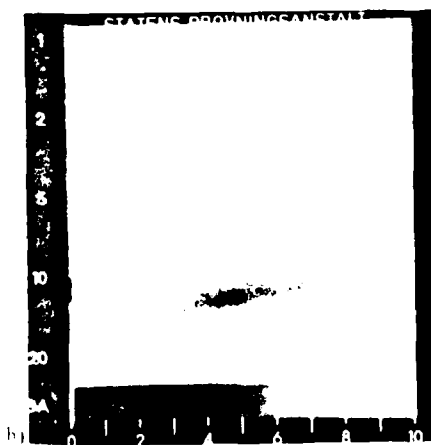
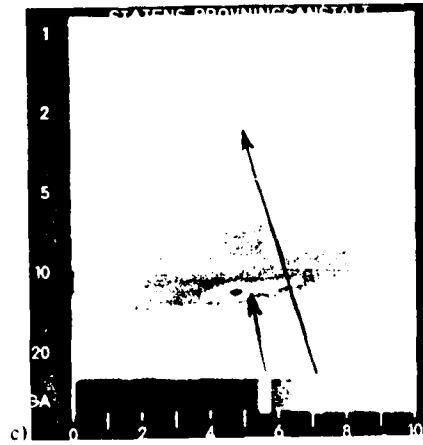
- Alt. c) See FIG. 100. Generally, the results of the investigations of polyurethane foam insulated joints were good. Both the tightness and the insulation values were satisfactory. At some isolated point, a blister had formed in the material, which caused a certain air leakage. The results of measurements twelve months after the final inspection were unchanged and satisfactory.

FIGURE 100: Fully satisfactory function of joint at joist.

With the exception of a minor defect, fully satisfactory tightness was obtained with this system.

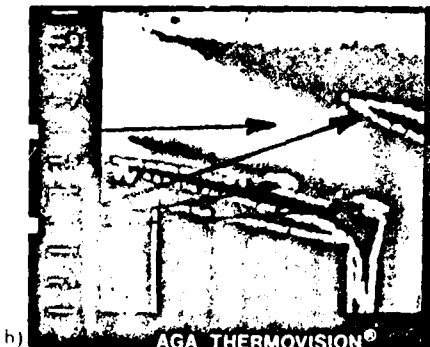
two months later. The cooled surface portions appear more clearly due to increased inward air leakage as compared to previous measurement. Air leakage through the joint has increased due to movements of the wood construction.

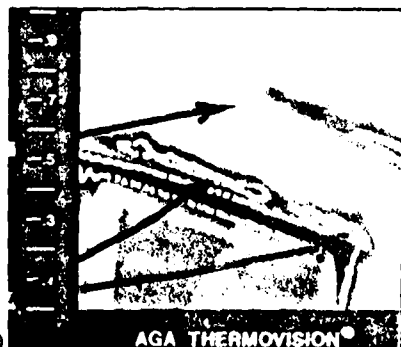
FIGURE 103: Deficient tightness function in joint between window and wall with inward air leakage to a great extent where only one strip, not folded, was placed in the joint.

b) Thermogram of surface portion at window connection to wall portion. Surface portions at joint of window frame are cooled both at upper horizontal joint and at vertical connection. Cooling related to inward air leakage through joint between window frame and wall portion.

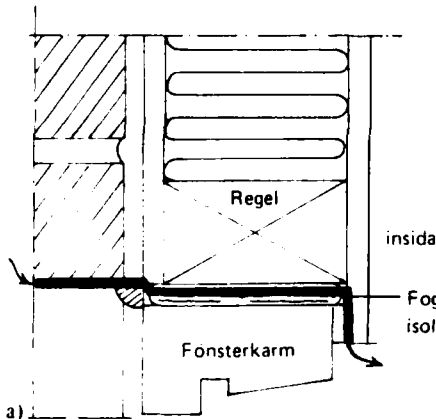
FIGURE 104: Satisfactory tightness function of joint between window and wall (exception: locally at wedge).

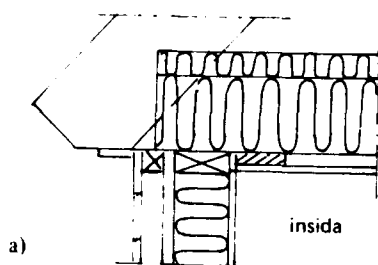
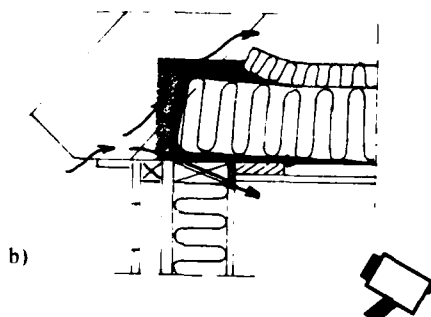
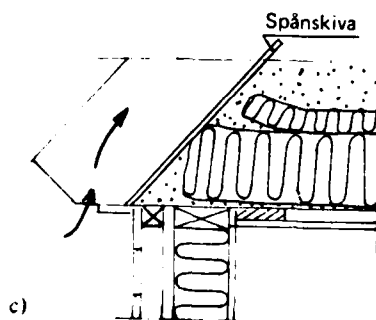
FIGURE 107: THERMOGRAMS TAKEN BEFORE AND AFTER ACTION AS PER FIG. 106

- a) Thermogram of cooled surface portion of roof (before action). Cooling caused by errors in insulation and tightness execution per fig. 106,
b). Inward air leakage through joint at the edge of the truss.

- c) Thermogram taken after action of the same surface portion of the roof as in a). The image shows satisfactory function of heat insulation and air tightness.

FIGURE 106: Deficient insulation and tightness function at soffit. Filling with cutter shavings well packed around construction details to prevent inward air leakage into the construction. Application of particle board to obtain an air space between outside roof and mineral wool,

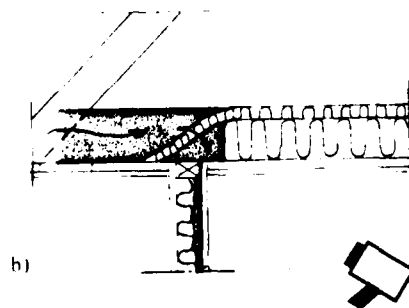
FIG. 109: THERMOGRAMS TAKEN BEFORE AND AFTER ACTION AS PER FIG. 108

The thermography of the building portion after the action showed significantly improved function of the construction in regard to both heat insulation and air tightness. The convective air movements in the wall portion ceased, see Fig. 109.

- Thermogram of cooled surface portion at roof angle and wall to the left of glass door (before action). Cause of deficiency, see fig. 108 b.
- $t_{ref} = + 20^\circ V$
 $\Delta I = - 3.8$ isotherm units
 $\Delta t = 5.5^\circ C$
 $v = 0$ m/s (air leakage into construction)
- Thermogram taken after action of the same surface portion as in picture a).
- $t_{ref} = + 18^\circ C$
 $\Delta I = - 2.8$ isotherm units
 $\Delta t = 4.0^\circ C$
 $v = 0$ m/s

FIGURE 108: Additional insulation to prevent air leakage into the construction at the soffit as well as at connections to construction wood in the beam tier.

Filling with cutter shavings, approx. 20 cm on top of existing insulation of approx. 20 cm, see fig. 109.

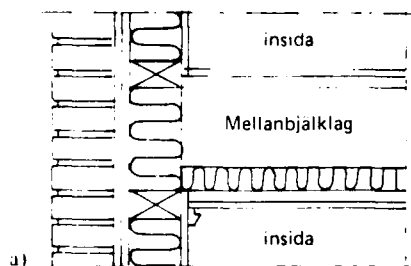
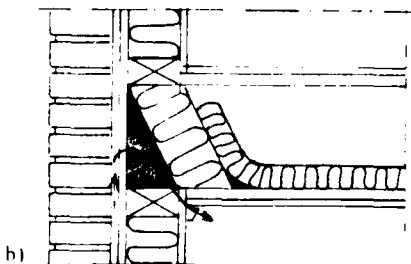
FIGURE 111: THERMOGRAMS TAKEN BEFORE AND AFTER ACTION AS PER FIG. 110.

The thermographic study of the building before
and after action showed considerably improved
function of both heat insulation and air tight-
ness of the construction. The control was per-
formed approx. 2 months after the action. At
the opening, the shrinkage of the foam material
was estimated at approx. 5%, see fig. 111.

FIGURE 110: Injection of carbamide resin foam into beam tier. Satisfactory insulation and tightness function after action.

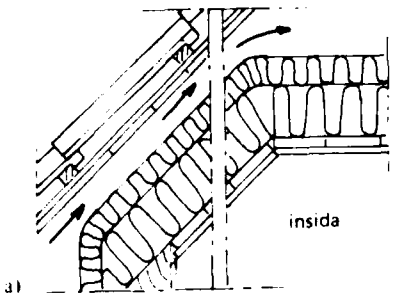
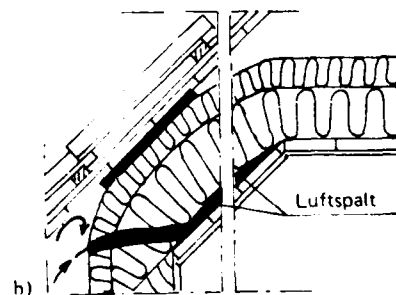
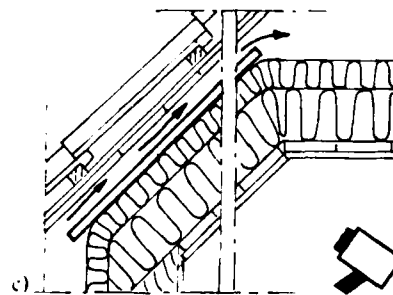
FIGURE 113: THERMOGRAMS TAKEN BEFORE AND AFTER ACTION PER FIG. 112

Thermography of the surface portion approx. 1 month after action showed a clearly improved function of heat insulation in the building portion, as compared with previous situation, see fig. 113.

a) Thermogram of cooled surface portion at slanted roof (before action). Cooling due to deficiency described in fig. 112, b).

c) Thermogram after action, of same surface portion as in a). The image shows significant improvement of heat insulation in the building portion. NOTE: Sun radiation through the window affects parts of the wall and roof portion (does not affect measurements on the roof).

FIGURE 112: Supplementation of slanting roof insulation with mineral wool panels and adding wood fiber panel on the spar to obtain air space between insulation and wood panel. Acceptable insulation and tightness after action.

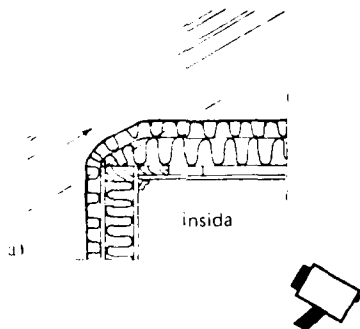
- a) Construction of roof truss
- b) Observed deficiency of insulation and tightness (compartment at left). Improvement of wind protection and insulation shown at right in picture (performed from the outside).
- c) Photo of action taken:

The mineral wool mat was lifted and cutter shavings packed around the rafters at the truss connections. The mineral wool mat was carefully replaced and fastened to the rafters. From the outside, the wind protection has been improved with a wood fiber panel.

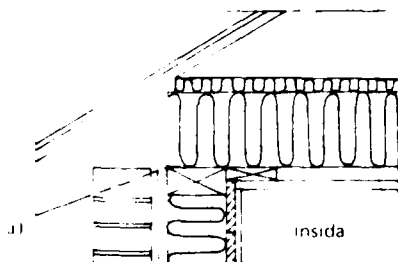
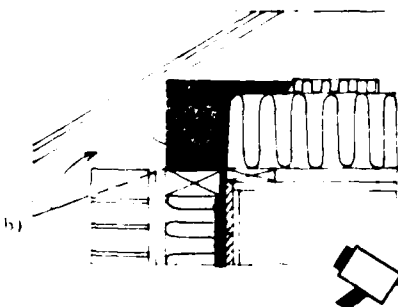
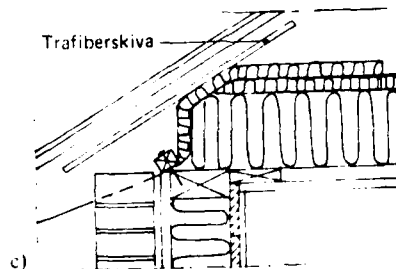
FIGURE 117: THERMOGRAMS TAKEN BEFORE AND AFTER ACTION AS PER FIG. 116

Thermography study after action showed satisfactory results with good tightness at soffit and even temperature distribution over the surface. Control approx. 2 years after first thermography and approx. 6 months after action, see fig. 117.

a) Thermogram of cooled area at roof angle (before action). Jagged form of cooled surface shows cooling caused by inward air leakage. Leakage into residential room could not be measured or observed. Cooling caused by outdoor air leaking into construction and propagating in the wall between mineral wool and gypsum panel.

b) $t_{ref} = + 22^\circ\text{C}$
 $\Delta I = - 1.7$ isotherm units
 $\Delta t = 2.5^\circ\text{C}$
 $v = 0$ m/s (no air leakage into room)

FIGURE 116: Supplementation of soffit insulation at saddle roof by opening from the outside. Existing mineral wool insulation has been corrected and supplemented with mineral wool mat with wind barrier which has been fastened. Acceptable insulation and tightness function after action.

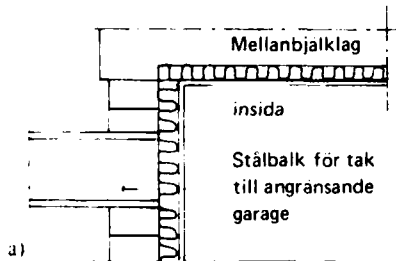
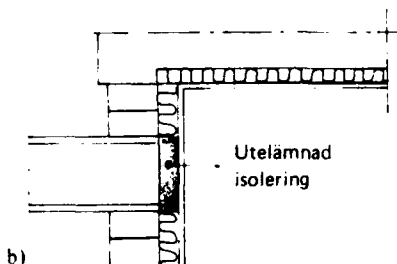
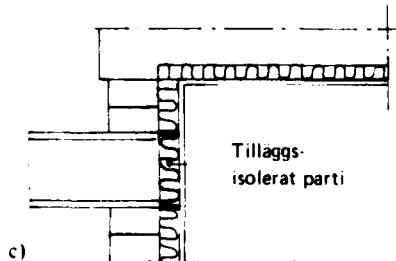
FIGURE 119: THERMOGRAM SHOWING SURFACE PORTION OF WALL BEFORE AND AFTER ACTION AS PER FIGURE 118.

- a) Construction of wall at connection to load-carrying beam.
- b) Observed deficiency. Cooled wall portion due to bad insulation execution at beam connection. Insulation material lacking between steel beam and interior wall covering.
- c) Sketch of action taken.

a) Thermogram of partially cooled portion of wall surface at roof angle (before action). Cooling caused by attachment of steel beam. Insulation on the warm side not performed, see fig. 118 b).

FIGURE 118: Supplementation of outside wall with mineral wool panel in wall portion with cold bridge due to incomplete insulation. Fully satisfactory insulation and tightness functions after action.

Thermography of the wall portion after action shows fully satisfactory insulation function of the insulation. Control performed some 2 years after first thermography and approx. 6 months after action, see fig. 119.

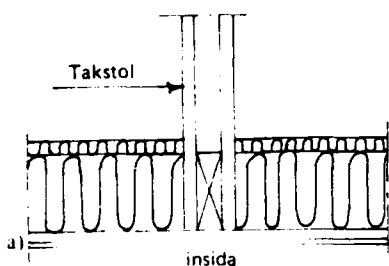
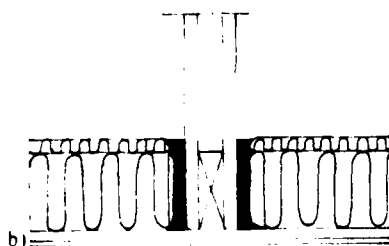
FIGURE 121: THERMOGRAM SHOWING SURFACE PORTION OF ROOF TRUSS BEFORE AND AFTER ACTION ACCORDING TO FIGURE 120.

b) Deficiencies in insulation and tightness execution of beam tier at truss.

Thermography study of the building portion after the action gave satisfactory results, but a minor defect at the electrical outlet for a ceiling lamp is still visible, see fig. 121.

FIGURE 120: Supplementation of beam tier insulation with mineral wool insulation. The paper backed mineral wool mat has been corrected and attached in the right position by nailing it to battens. Acceptable insulation and tightness function after action.

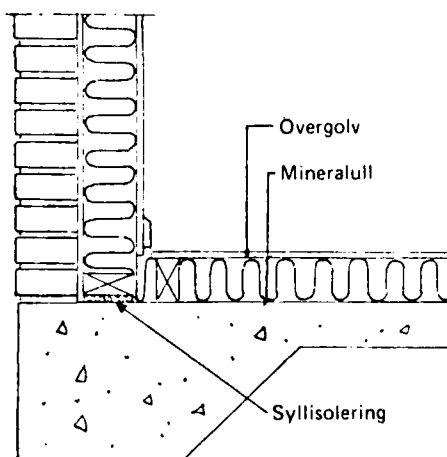
TABLE 6: Total number of houses/apartments in investigated projects.
Single dwellings: 1,365. Multiple dwellings: 20/291.

Deficient function for heat insulation and tightness is relatively frequent, particularly in areas close to outside wall. The defects are mainly due to unsatisfactory filling and fitting of the insulation material at the edges of the joist tier. Air leakages through connections at the joists are frequent. The cold outdoor air can propagate in the joist tier and leak into the residential areas. Efficient and careful sealing of the joist tier and good filling with the heat insulation material in the compartments between the joists are required, particularly in the outer edge areas, if the function is to be fully satisfactory. This decreases the effect of possibly occurring cold bridges.

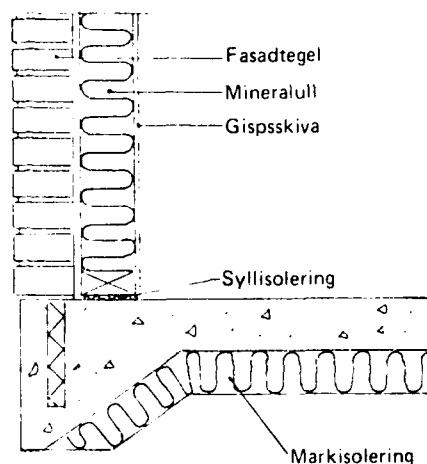
TABLE 7: Total number of houses/apartments in the investigated projects.
Single dwellings: 205. Multiple dwellings: 7/165.

The deficiencies observed here are due either to deficient joist sealing resulting in direct air leakage into the residential area, or to uneven function of the insulation of the outside beam. These conditions frequently cause abnormally strong cooling of portions of floors close to outside walls. Inward air leakage in these portions usually causes great local temperature variations with distinct borderlines in the thermogram. Uneven function of the outside beam insulation causes lesser temperature variations, usually with diffuse borderlines of the cooled surfaces. However, this construction type gives a lower floor temperature than does construction type bb 1.

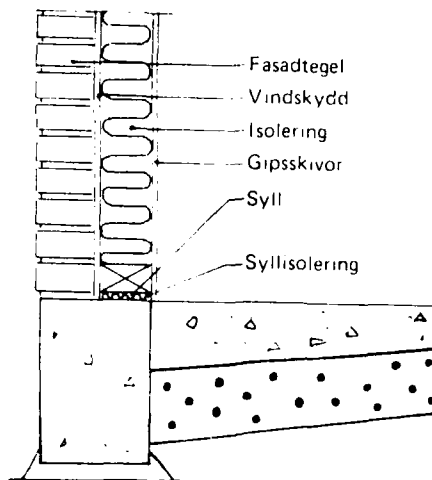
TABLE 8: Total number of houses/apartments in the investigated projects.
Single dwellings: 1,758. Multiple dwellings: 55/997.

The deficiencies observed in this construction type are mainly inward air leakages due to insufficient function of the joist sealing. The cooled portions are generally limited to the edge portions of the joist tier, in connection with the tier edge proper. Otherwise, the insulation function of the joist tier is not affected.

From the point of view of sealing, the construction depends on careful surface leveling at the edges of the joist tier as well as an efficient joint sealing system. As construction type bb 2, this construction type gives a slightly lower floor temperature than construction type bb 1.

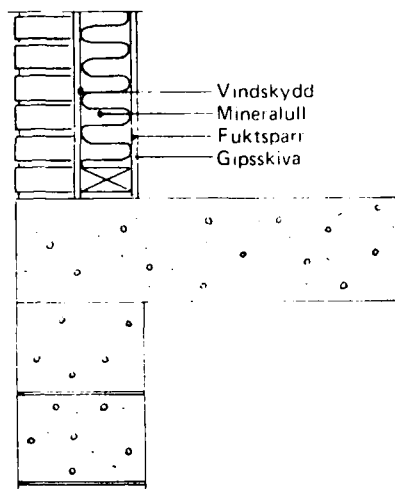
TABLE 10: Total number of houses/apartments in the investigated projects.
Single dwellings: 41. Multiple dwellings: 0.

The deficiencies in conjunction with this constructop type are usually related to leaking connections at the edge of the beam tier, frequently resulting in air leakage into the residential area. Otherwise, the beam tier functions satisfactorily. When the joist sealing is fully functional, the effect of the cold bridge is relatively insignificant.

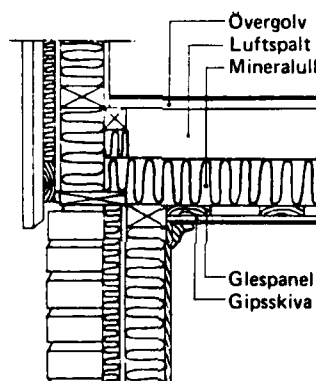
TABLE 11: Total number of houses/apartments in the investigated projects.
Single dwellings: 1,906. Multiple dwellings: 0.

The results indicate a relatively high frequency of deficiencies. One should observe the importance of the insulation material filling the entire space in the beam tier at the edges, approx. 1 m from the outside wall.

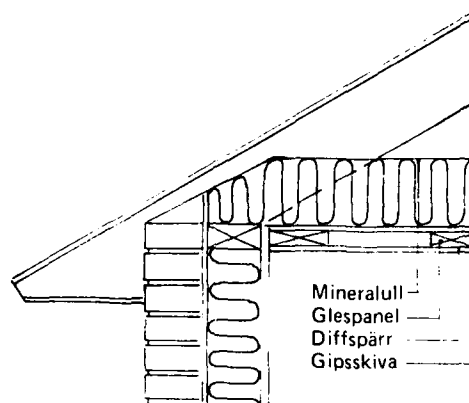
TABLE 13: Total number of houses/apartments in the investigated projects.
Single dwellings: 1,352. Multiple dwellings: 29/553.

Electrical installations in the beam tier often make it difficult to execute the work well and may thus cause deficiencies in the insulation and sealing layers of the construction.

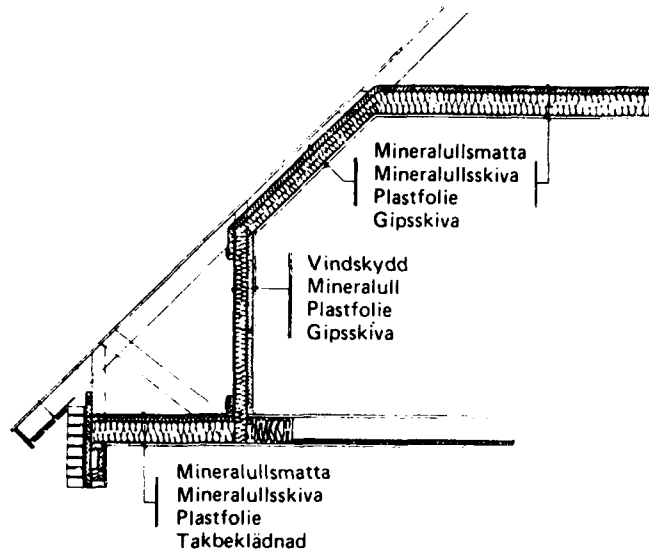
TABLE 14: Total number of houses/apartments in the investigated projects.
 Single dwellings: 1,077. Multiple dwellings: 0.

In the cases of horizontal attic beam tiers, the deficiencies are predominantly localized to the connection of the beam tier to the gable walls, due partly to insufficient filling of the insulation material in contact with the studs, partly to deficiencies in the sealing layer of the construction. As has previously been pointed out, this may also affect the interior of the beam tier in the case of screen panel construction.

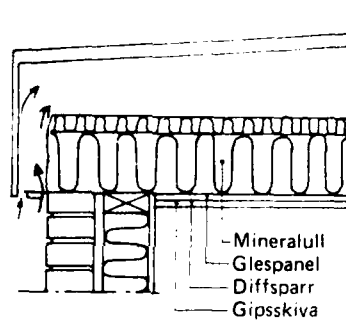
TABLE 15: Total number of houses/apartments in the investigated projects.
Single dwellings: 703. Multiple dwellings: 0.

Inadequate execution of insulation and sealing in the attic beam tier may also cause cold air to leak inward and propagate in inside walls.

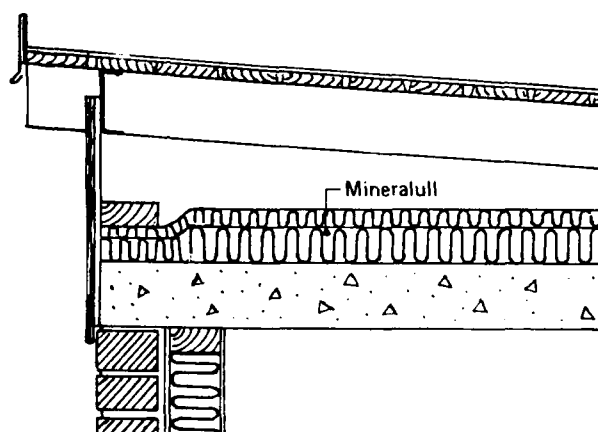
FIGURE 16: Total number of houses/apartments in the investigated projects.
Single dwellings: 81. Multiple dwellings: 33/778.

Air leakage through connections of beam tiers to outside walls seem to occur to a certain extent, when the outside wall and the beam tiers are not of the same material.

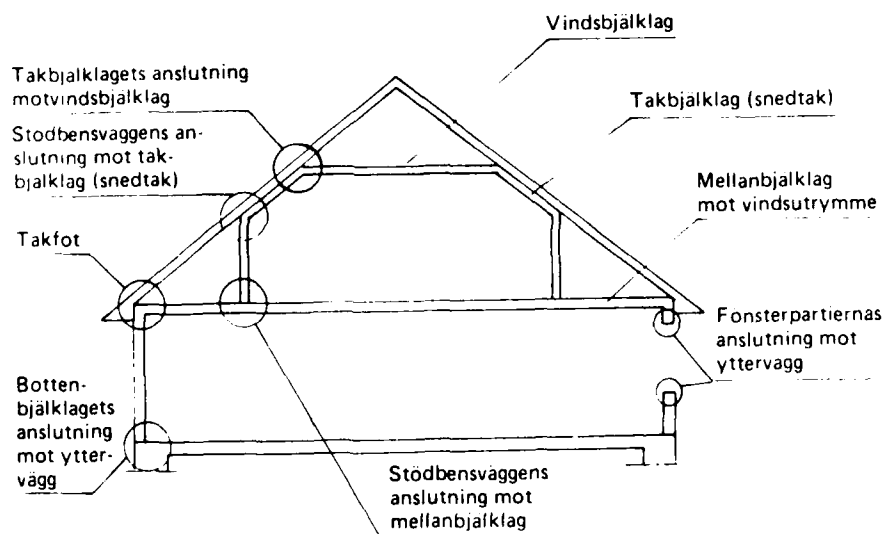
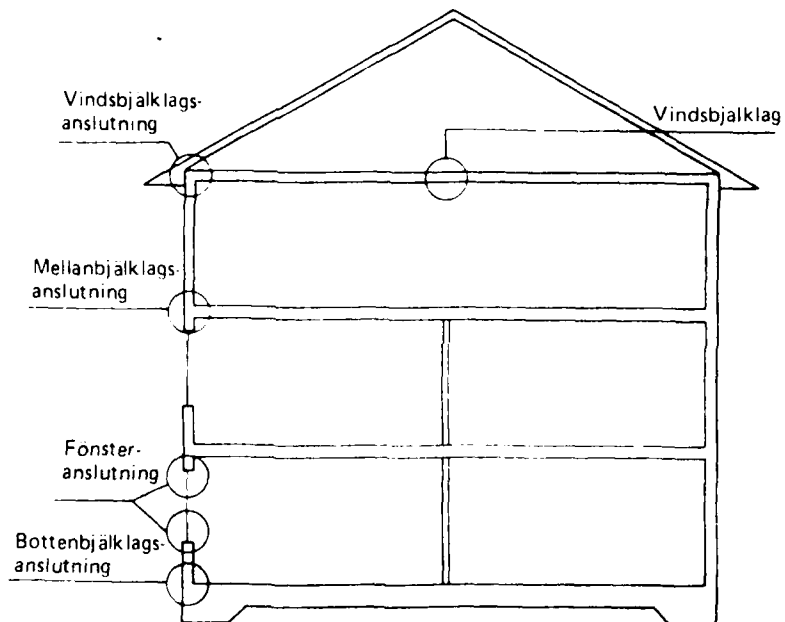
FIGURE 123: Single dwellings and multiple dwellings: the construction details particularly sensitive from the standpoints of heat insulation and tightness have been indicated.

Air leakage through joints and connections as well as inadequate filling of insulation material in the portions marked in FIGURE 123 a) - b) seem to be the most frequent types of deficiencies. Such errors can cause an unsatisfactory temperature distribution and unpleasant air movements (drafts) in the residential areas as well as locally low surface temperatures on construction surfaces, with risk for condensation and dirt deposits. Deficiencies in the inner or outer sealing layers of the construction cause risk for air penetration of the construction and may cause accumulation of moisture.
